METAL ROOFING: HAIL DAMAGE
CLEBURNE TRAINING AND FITNESS CENTER
1014-A NORTH NOLAN RIVER ROAD; CLEBURNE, TX 76033

BACKGROUND

This firm was contacted and retained in August of 2024 by Mr. Mark Kressenberg of Thompson Coe with respect to the roof of subject property to opine concerning the extent of damage from a recent hail event or events. We were asked to assess whether or not the damage constitutes “functional” damage or “cosmetic” damage. This firm was specifically asked to review expert reports and documents pertaining to a claim for functional damage due to a hailstorm on March 16, 2023 and render our opinions with respect thereto.

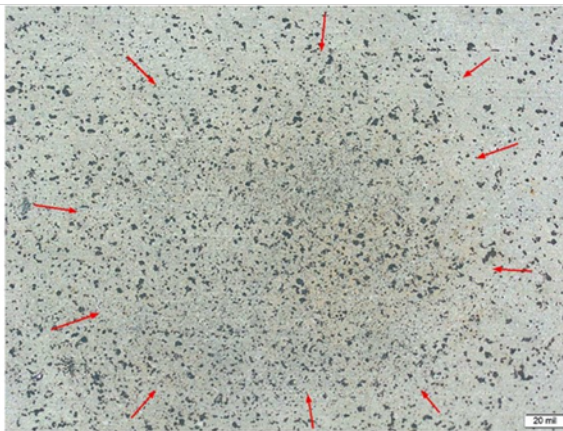
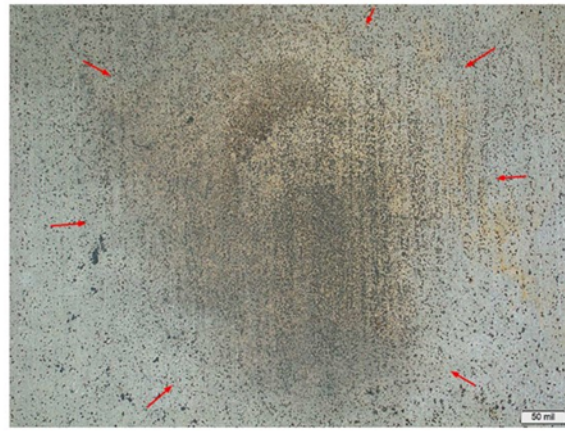
Figure 3: Stereo optical microscope image representative of the impact point of damage on roof panel No.1 impact point 1A (Figure 1). The scale bar is in mils (0.001”).

Figure 5: Stereo optical microscope image representative of the impact point of damage on roof panel No.1 impact point 1B (Figure 1). The scale bar is in mils (0.001”).

Figure 1. Figures 3 and 5 from the Element report showing suspected age difference between a more recent divot (left) and an aged divot (right) located approximately 6 inches apart on roof panel No. 1.

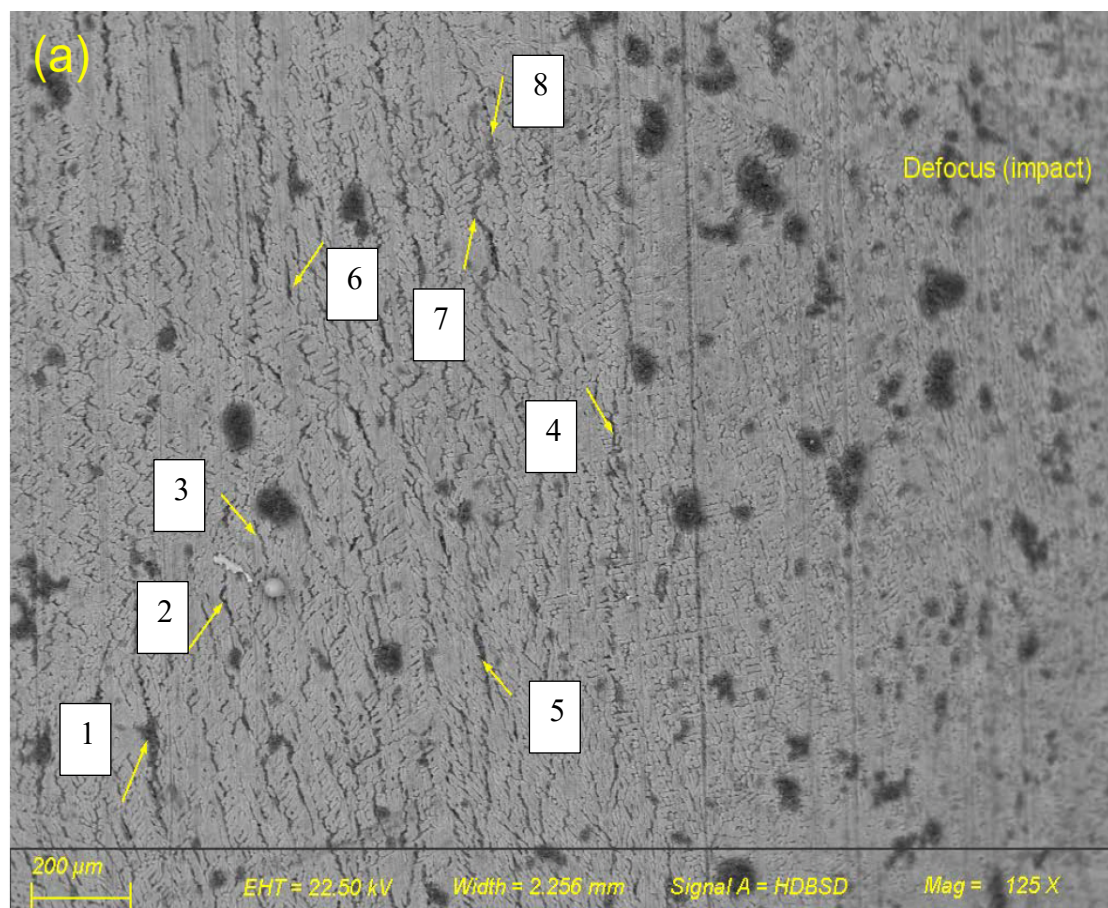
2) Regarding opinions 4 and 5, we believe the claimed presence of microcracks in the coating as highlighted in Figure 7a is the main reason for these opinions. However, the size of these supposed microcracks must be known before such opinions can be considered credible. That is, are the microcracks of significant size (width) to be judged detrimental to the coating's ability to offer corrosion resistance or to have adversely impacted the roof's service life?

- a) Using photo 7a, shown below in Figure 2, the widths of the microcracks were measured based on the scale shown at the bottom of the photo. The eight microcracks range in size from 0.008-0.033 mm, with an average of about 0.015 mm.

Figure 2. Figure 7a from the Element report used to measure crack widths.

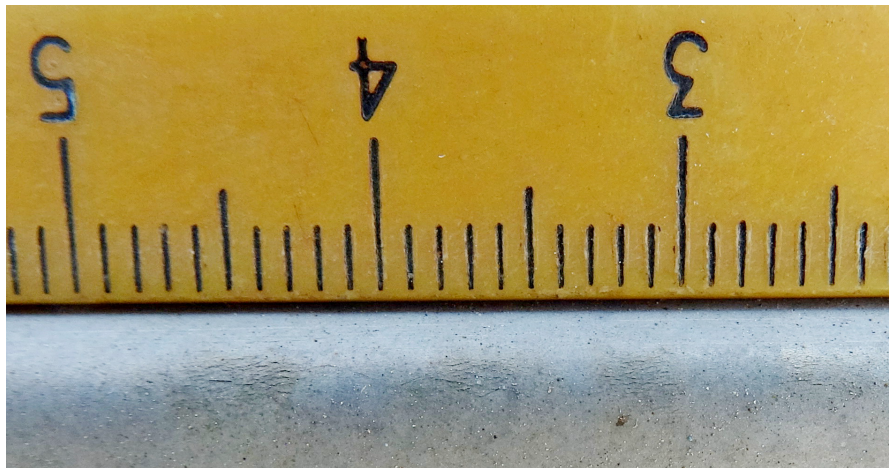
To put this degree of microcracking into context, the photo in Figure 3 shows a roof panel profile rib radius on a roof in Denver, CO. While there are rust stains in the microcracks, they have not progressed over time or negatively impacted the continuing corrosion resistance of the Galvalume coating. Nor have they been detrimental to the roof's service life since the roof has been functioning without issue for 44 years (roof installed in 1977, photo taken in 2021).

Figure 3. Denver roof profile rib radius showing microcracks; roof in service 44 years (scale in mm).

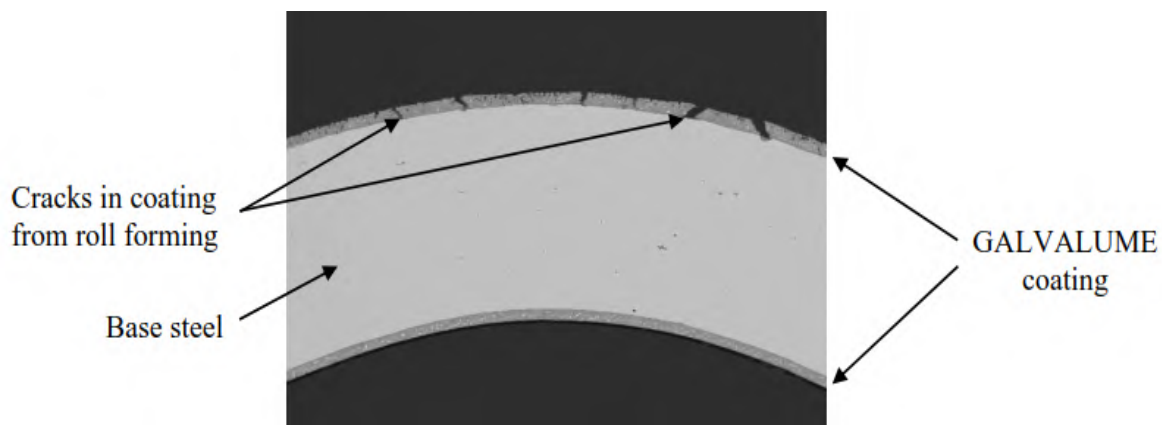
A cross-sectional micrograph of this profile rib radius at 75X magnification is shown in Figure 4, below. Note the presence of micro-cracks on the upper coating surface attributable to the normal “trauma” associated with roll forming the flat coil into a roofing panel.

Figure 4. Metallographic cross-section of Denver profile rib radius at 75X magnification.

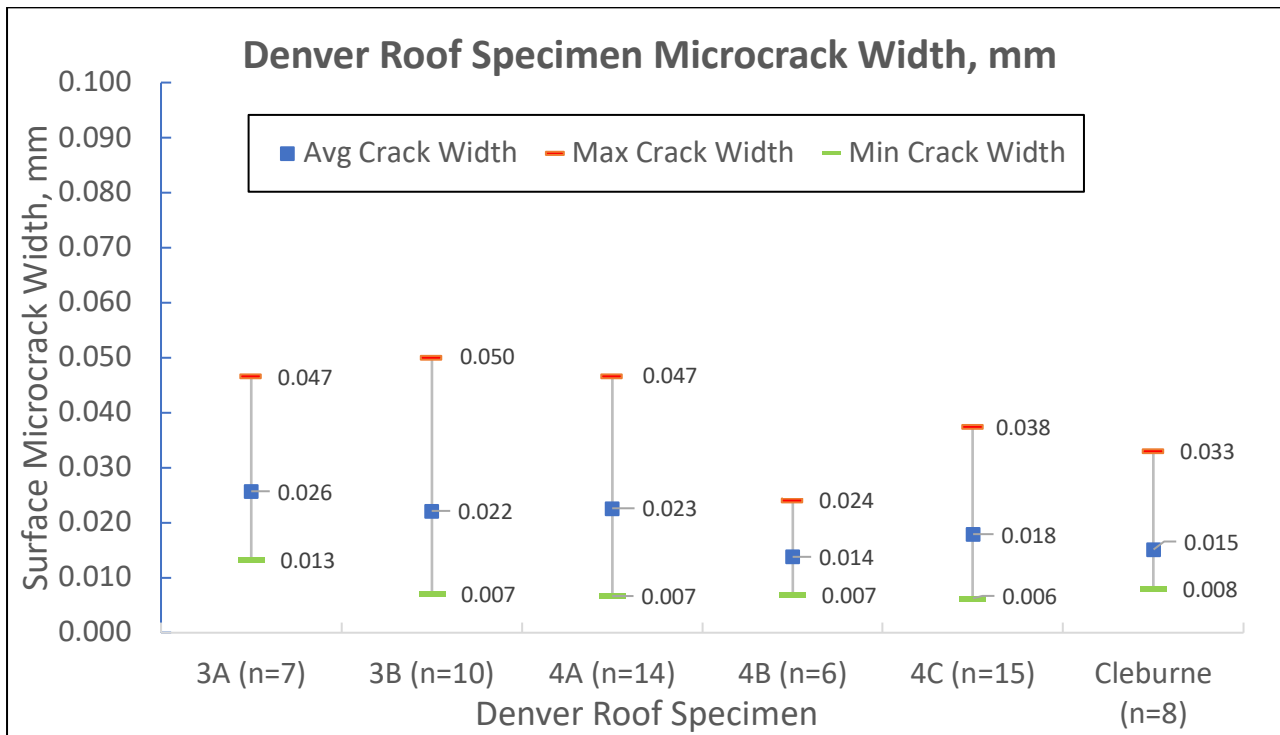
- b) *The widths of the microcracks from the Denver roof and the Cleburne roof sample 1A are plotted together for comparison in Figure 5, below. Note that the sizes of microcracks on the Cleburne roof are smaller than those on the Denver roof which continues to exhibit excellent performance after 44 years. Thus opinions 4 and 5 expressed in the Element report are not supported by the facts of empirical data.*

Figure 5. Galvalume coating microcrack widths observed on the Denver roof compared to those on the Cleburne roof.

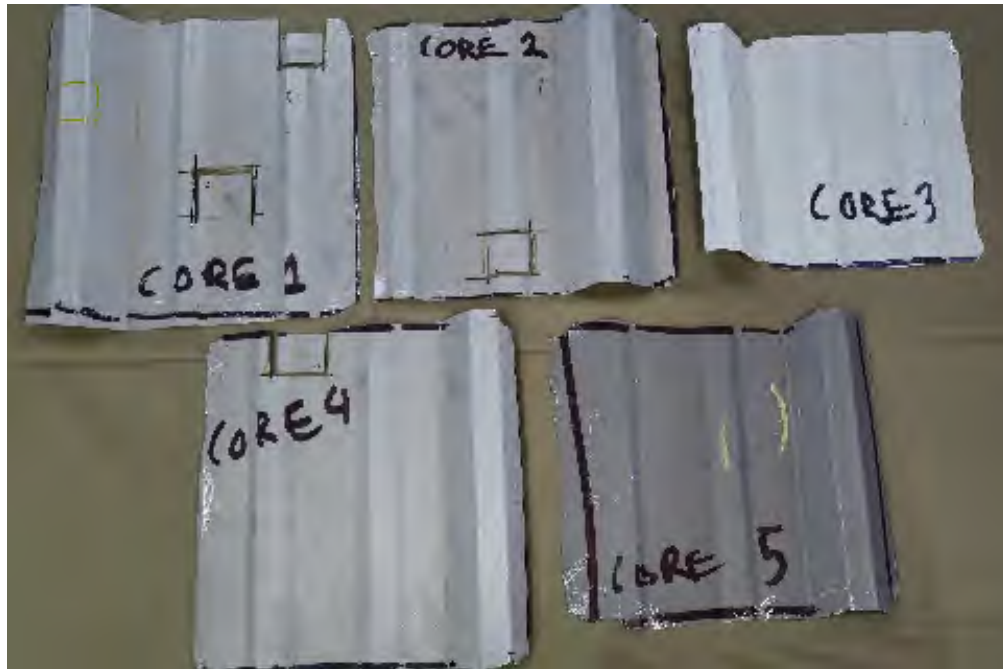
Roof samples were received from Element Materials Technology on September 24, 2024. The samples included five larger panel pieces, and four smaller specimens cut from three of the larger pieces, as shown in **Figure 6**. As they were the basis for the Element report, it is assumed they are representative of the “damage” done to the roofs as a result of the March 16, 2023 hailstorm. It is unclear from the report which of the several buildings at the Cleburne site served as the source for these samples.

Figure 6. Roof panel samples representative of damage from the March 16, 2023 hailstorm.

Seven divots from these samples were available for analysis. Measurements were made of the depth and width of each divot. The measurements are shown in Table 1.

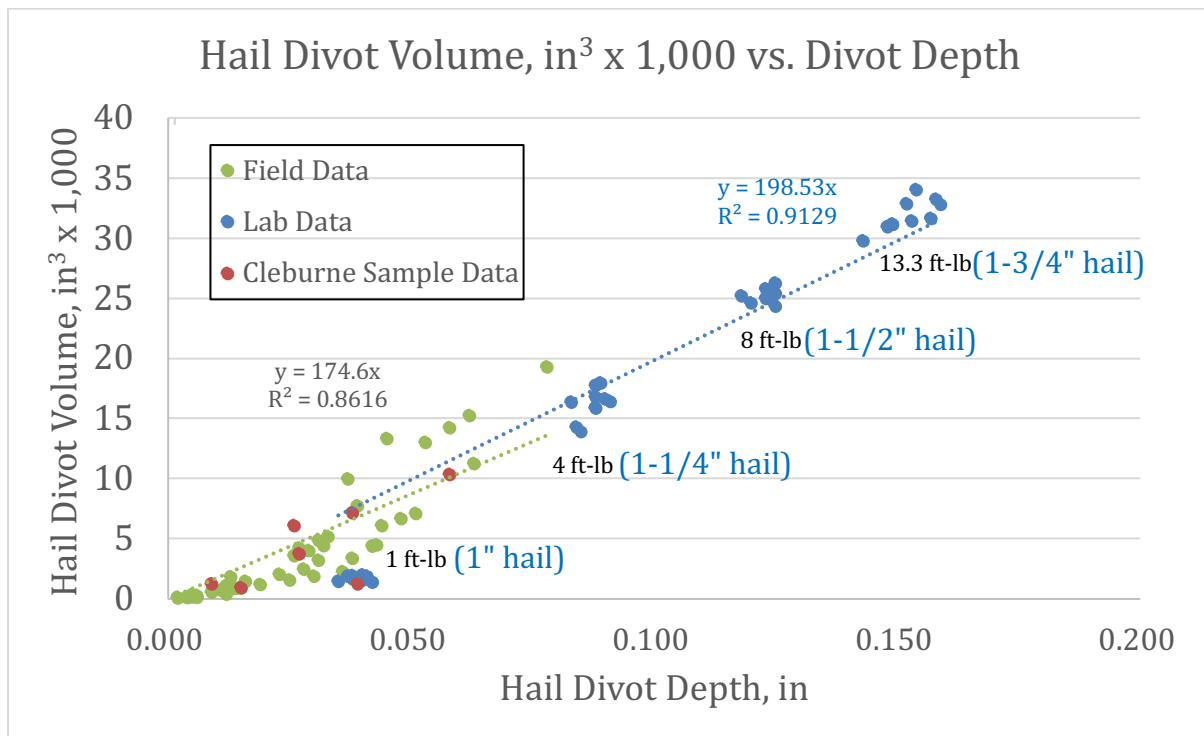
These data can be compared with published data which correlates divot size with the impact energies associated with the hail diameters that produce such divots⁷. The Cleburne divot data are plotted on one of the figures from that published paper in **Figure 7**. The Cleburne data can be seen to fall primarily in the range of impact energies representing a hail diameter of 1", and not the 2-2.5" claimed in the Spradling and HailTrace reports.

Figure 7. Divot depth vs. divot volume and correlation with hail impact energies and corresponding hail diameters⁷.

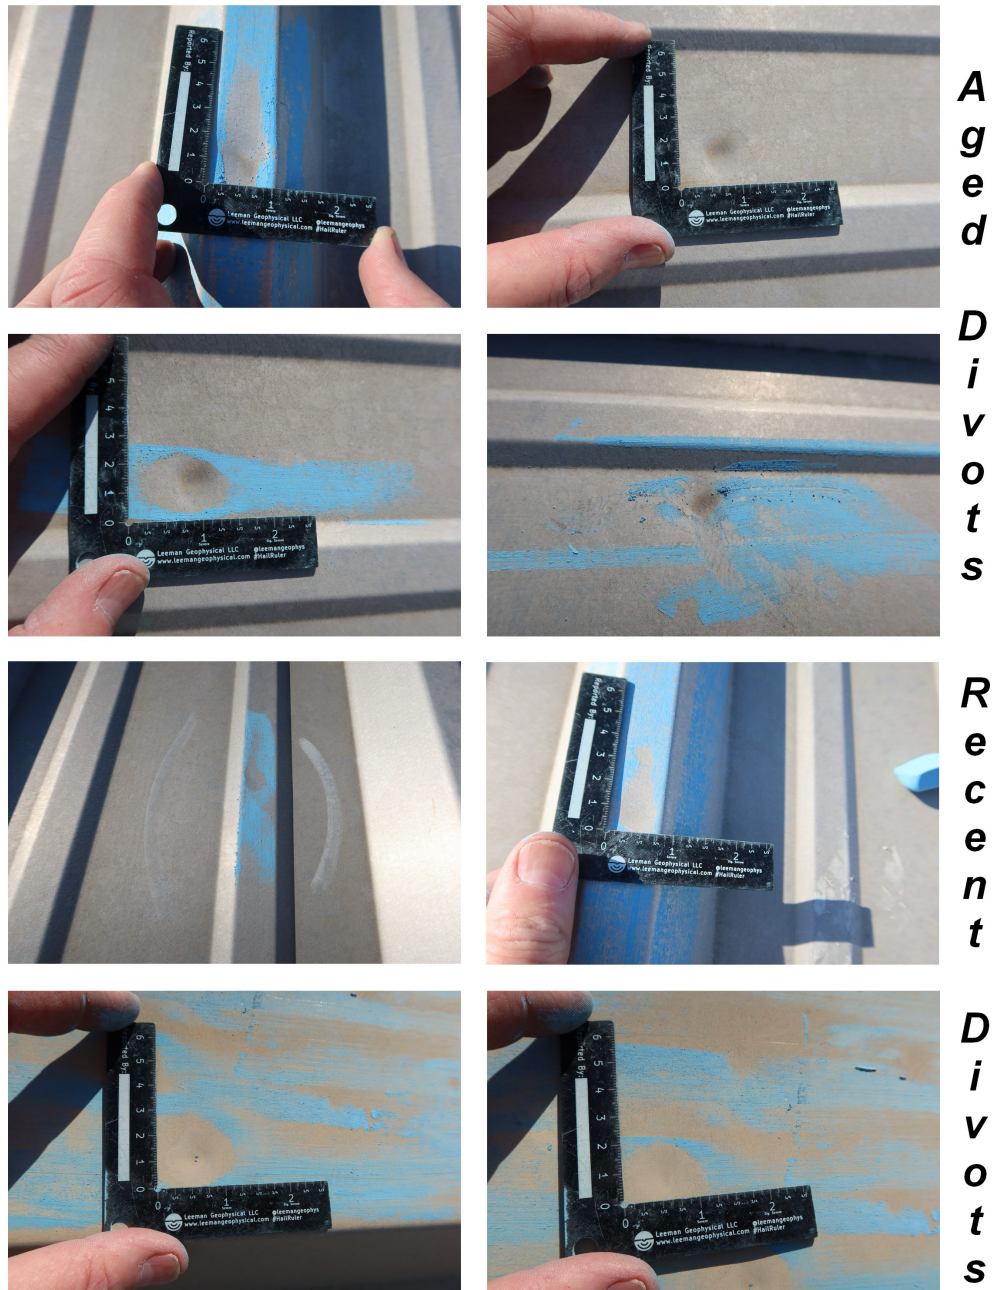
641 jobsite photographs, taken on September 17, 2024 by a Thompson Coe representative, were received from Thompson Coe on September 24, 2024. A visual review of these photos shows that about 45% (21 of 47) of the divots captured in close-up photos are aged due to the dark accumulation of dirt and debris in the divots, while the remaining 55% (26 of 47) are more recent. The representative photographic montage in **Figure 8** shows these visual differences. Based on our forensic investigative experience (see pp. 2-3 of this report), our opinion is that the aged divots were produced by a hail event prior to March 16, 2023.

Figure 8. Visual appearance of aged divots (top four photos) compared to that of more recent divots (bottom four photos) based on jobsite photographs.

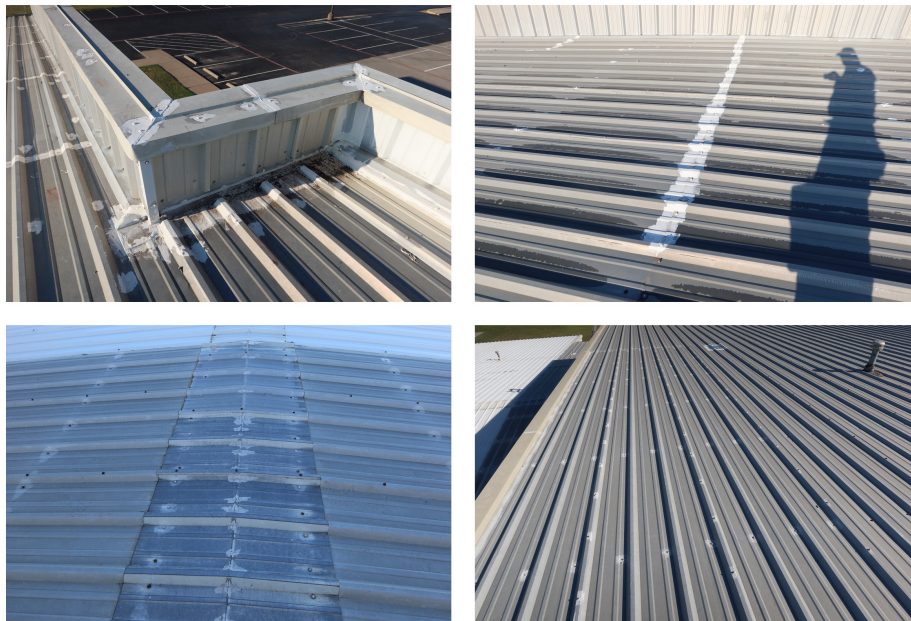
***Multiple Areas of
Attempted Leak
Repairs***

Many areas of the roofs have apparently leaked for years as evidenced by the application of sealant to endlaps, fasteners, and flashings and significant aging of those remedies as seen in **Figure 9**.

Figure 9. Several examples of roof areas where sealant has been applied in attempts to stop leaks.

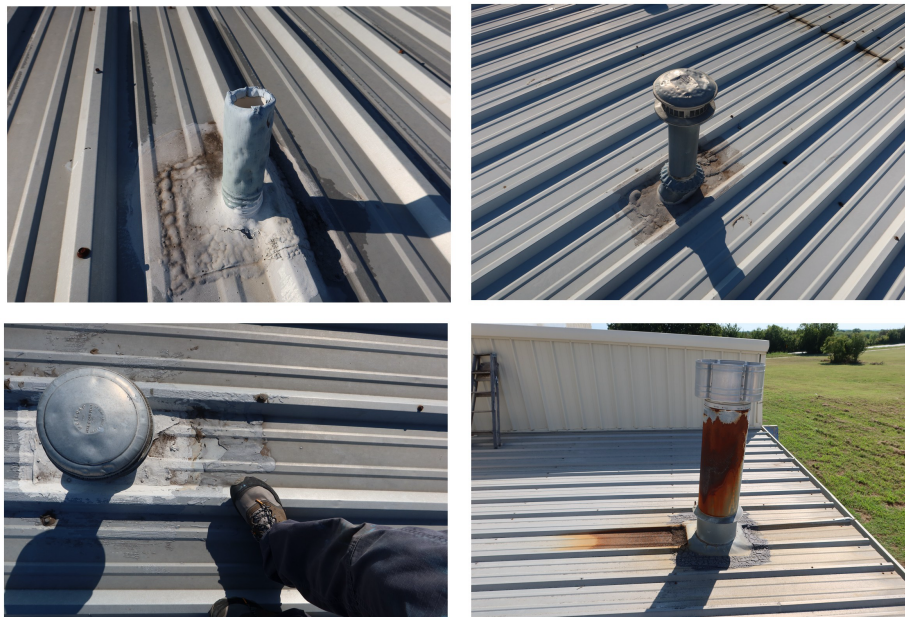
***Roof Penetrations
Heavily Corroded and
Patched to Stop Leaks***

Roof penetrations have also been the source of leaks in the past as evidenced by the many areas shown in **Figure 10**.

Figure 10. Roof penetrations exhibiting significant corrosion and evidence of leaking.

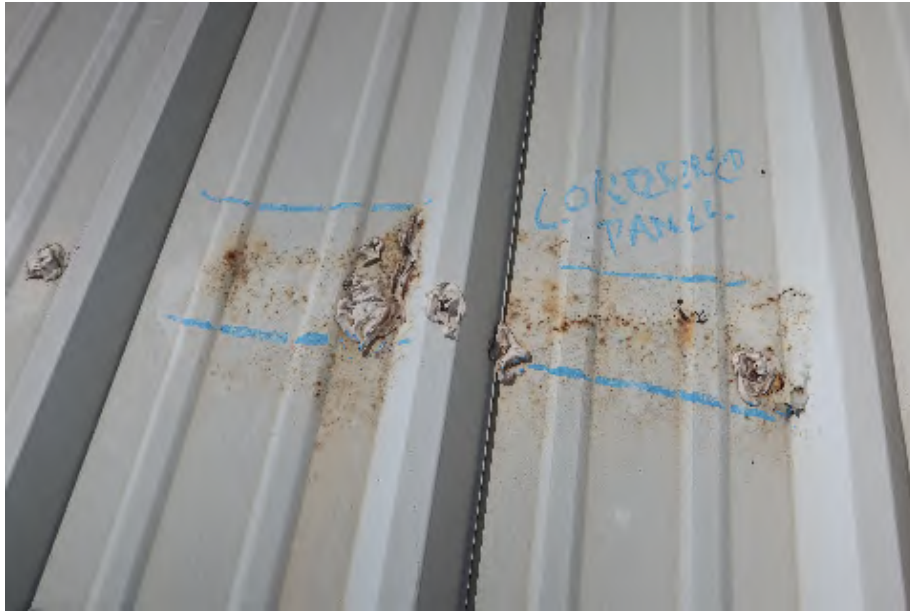
One particular area exemplifying problems that have been ongoing for many years is shown in **Figure 11**. This is an example of inside/out corrosion which occurs when underlying insulation becomes wet. Corrosion through the panel occurs due to the moisture and general lack of oxygen underneath the panel. The panel in this case has been corroded completely through and will allow water intrusion every time it rains.

Figure 11. Inside/out corrosion leading to perforation of the roof panel and subsequent leaks.

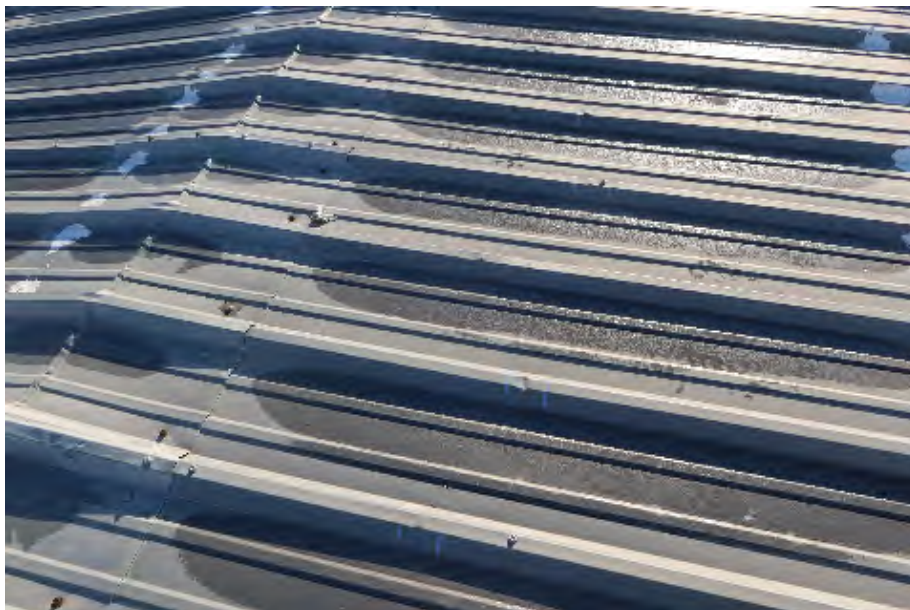
Significant deformations on some profile ribs, such as shown in **Figure 12**, are known as rib crippling caused either by improper installation practices when trafficking the roof during construction, or improper foot traffic on the installed roof during maintenance. They are not to be confused as evidence of hail strikes.

Figure 12. Evidence of rib crippling from installation or maintenance issues.
